Manhole Inspection Summary

Manhole # S33CC_007MH

Insp Date: **4/17/09 2:23 PM**

Location Address: **1001 N. CHARLES ST**

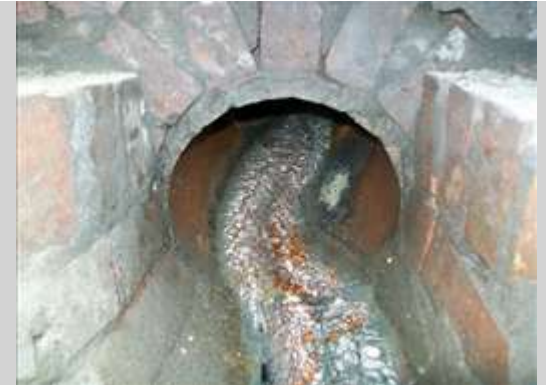
12 O'Clock Outflow

12 in. Circular Gravity Sewer
Pipe Out @ 12 O'Clock

Pipe Height: **12** (in.) Rod and Bar (Angled)
Pipe Material: **Clay** ☐ Pipe Lined
Invert Depth: **10.50** (ft.) Flow Characteristics: **Slow**
Deposits: ☒ None ☐ Mud ☐ Sludge ☐ Debris ☐ Grease
Silt Depth: **0** (in.) Deposits Extent:
Infiltration: **None** Pipe Seal Cond: **Sound**

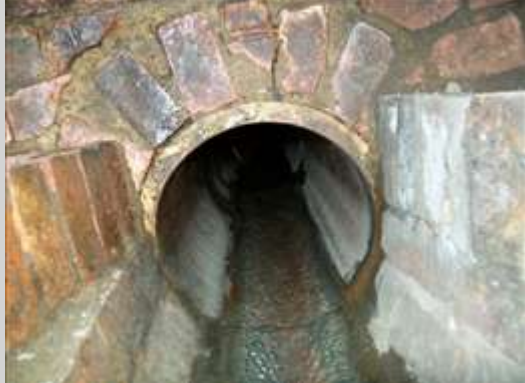
9 O'Clock Inflow

10 in. Circular Gravity Sewer
Pipe In @ 9 O'Clock

Pipe Height: **10.8** (in.) Rod and Bar (Angled)

Pipe Material: **Clay** ☐ Pipe Lined

Infiltration: **None** Pipe Seal Cond: **Sound**
